PORT OF BEIRUT'S CURRENT STATUS

Port of Beirut damage stocktaking

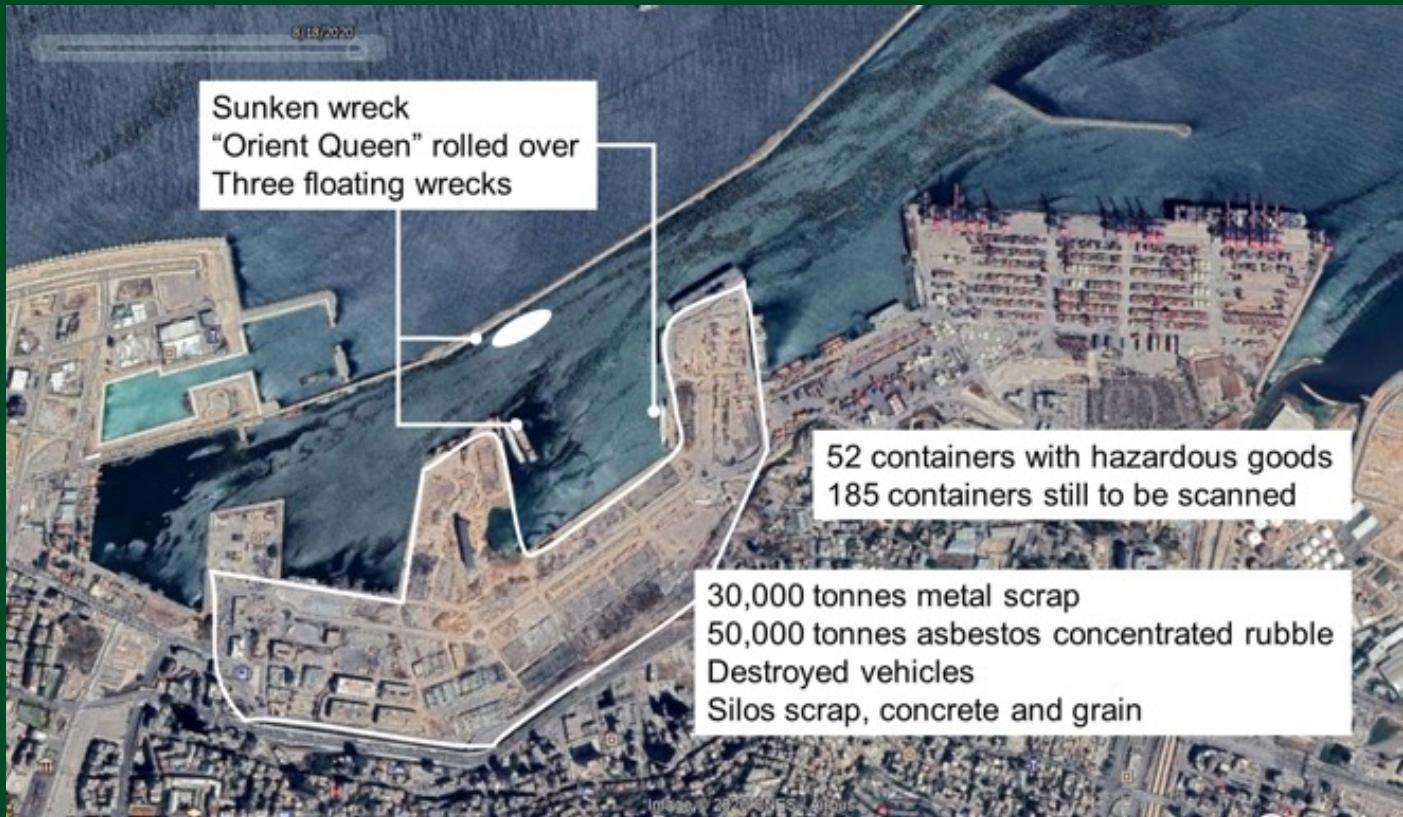
Figure 1: Port of Beirut salvage and removal

Because of the explosion, there are still five shipwrecks in the area of Quays 8 to 11 to be removed from their current positions:

- A sunken wreck inside the main breakwater (opposite Quay 8)
- The "Orient Queen" rolled over at Quay 11.
- Three floating wrecks

Furthermore, Combi Lift is currently preparing the removal of 52 containers already identified with hazardous goods, which were abandoned by their owners at the Beirut container terminal over the past years. As most of these containers cannot be moved anymore due to damages and advanced corrosion, this includes a rather high effort for re-packaging and removal as hazardous waste.

Another 185 containers spread all over the port are still to be scanned and removed as well. Combi Lift further reported a total of 30,000 tonnes of metal scrap and 50,000 tonnes of asbestos concentrated rubble to be removed from the port area. Lastly, also to be removed are a significant number of destroyed vehicles as well as the silo scrap, grain and concrete structures.

The salvage of the five wrecks is not contracted yet but considered urgent. The German based Harren & Partner Group of companies with its subsidiaries Combi Lift Projekt GmbH & Co. KG and CL Salvage GmbH & Co.KG, who are already in contact with Port of Beirut and the ship owners, would be prepared to salvage the wrecks including the removal of oil pollutants.

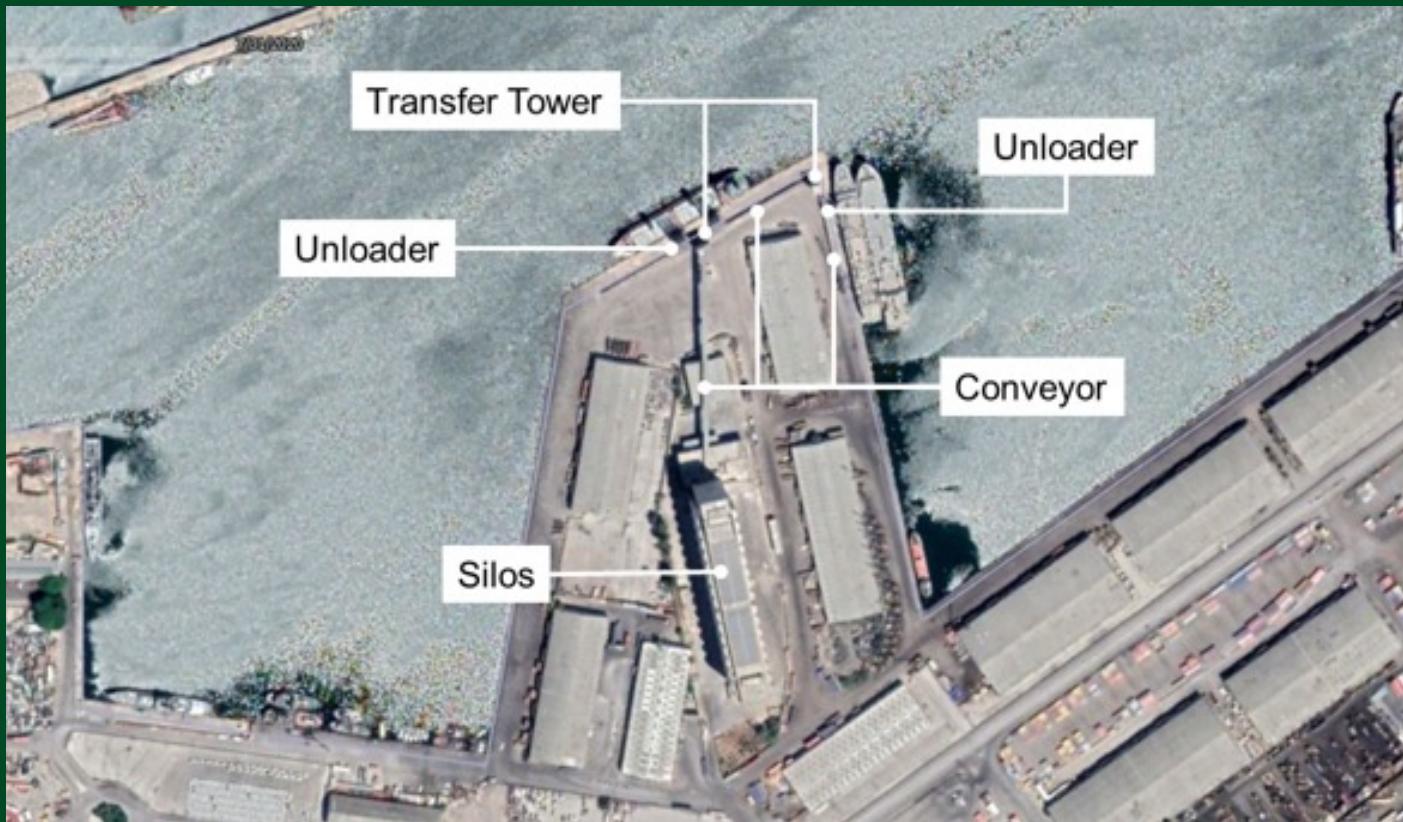
Figure 2: Port of Beirut grain import facility

The grain import facility with equipment for unloading vessels as well as the Silos for storage of the imported grain were located in immediate proximity of the explosion, hence considered a total loss. The unloading equipment consisted of two suction units at Quay 8 and a third unit at Quay 9, a conveyor belt system at the quayside (length approx. 250 m), a conveyor belt between the quay and the

silos (length approx. 170 m) and two transfer towers at the quayside. The silos had a capacity of 120,000 MT, divided in 48 cells 2,500 MT each, plus 50 smaller cells 500 MT each for emptying the large cells leaving room for a full vessel load. Loading onto trucks took place directly from the silos, in total four truck weigh bridges were also part of the facility.

Given the fact that the facility, which was almost 40 years old, is completely destroyed and the vacuum and conveyor setup with a relatively low suction speed of 600 MT/hour caused the bulk discharge to be much slower and thus more expensive than it should be, it is recommended to

develop a new state-of-the-art facility for future bulk operations. This new facility would be built at the most suited location within the port and will be dimensioned according to the forecasted volumes for grain import.

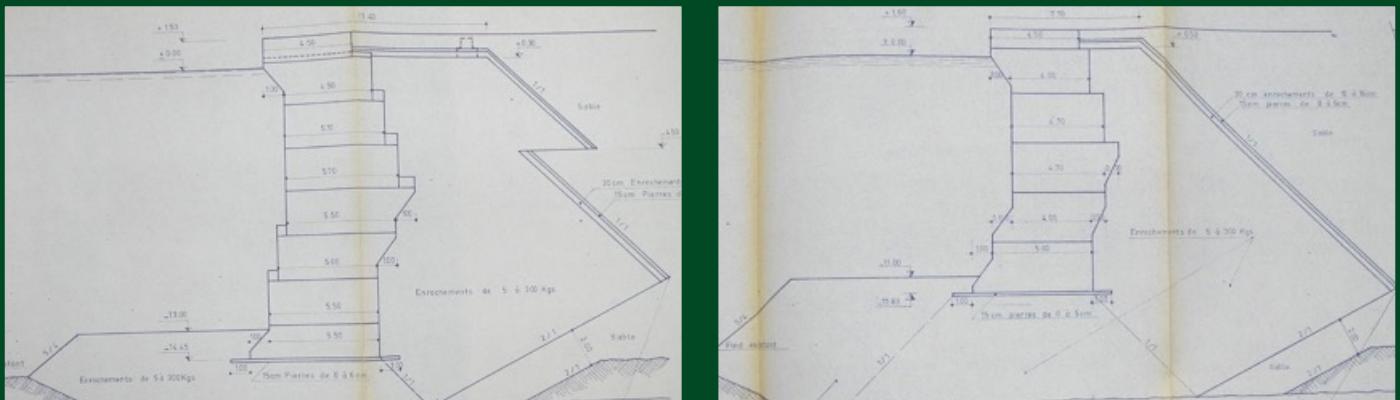
Figure 3: Cross sections at Quays 12 (left) and 13

As apparent from the photography and satellite imagery, a large section of Quay 9 (approx. 160m of quay wall and adjacent apron/terminal area, approx. 1 ha) was completely destroyed. In order to correctly estimate the level of damage of this quay, extensive structural assessments are required to be undertaken both above and below the water level to determine the extent of damage and to accurately understand the options for the quays repair/rebuilding.

In addition to the obvious damage to Quay 9, it is strongly recommended that extensive structural assessments be undertaken on all quays in the direct vicinity of Quay 9 in order to determine if any damage has been caused by the catastrophic explosion and subsequent aftershock that occurred. It is not common practice that the structures would be designed to resist such a blast.

Therefore, the Consultant would strongly recommend that in-depth inspections are completed for these critical infrastructure items as soon as possible, in order to assess whether the explosion caused any changes in the structural integrity of the quays (shifting or damaging of blocks, foundations, etc.). Depending on the observed damages to the quays in the closest proximity to Quay 9, additional surveys may also be deemed necessary to the quays situated further from the blast radius.

Quay walls should be thoroughly inspected to determine the extent of damages and the associated requirements for repair or replacements of quay wall sections. Extensive inspections should be undertaken in the closest proximity of the blast, with a decreasing level/frequency of tests being performed ad-hoc depending on the damage observed as the distance from the blast incidence zone is increased.

Preliminary inspections could include a visual assessment to observe any obvious shifting of blocks examining their alignment/position both over and above the water and to check for any visible damage in the quay blocks. In conjunction with the visual assessment to determine general alignment/position, topographic/bathymetric surveys may be completed along the quay walls to make a comparison with the as built drawings, thereby allowing an assessment of possible movements of the blocks and foundations. These preliminary checks should be completed by a detailed assessment of structural integrity of the quays with regard to any changes that may have been caused by the explosion (displacement of blocks, damages, etc.).

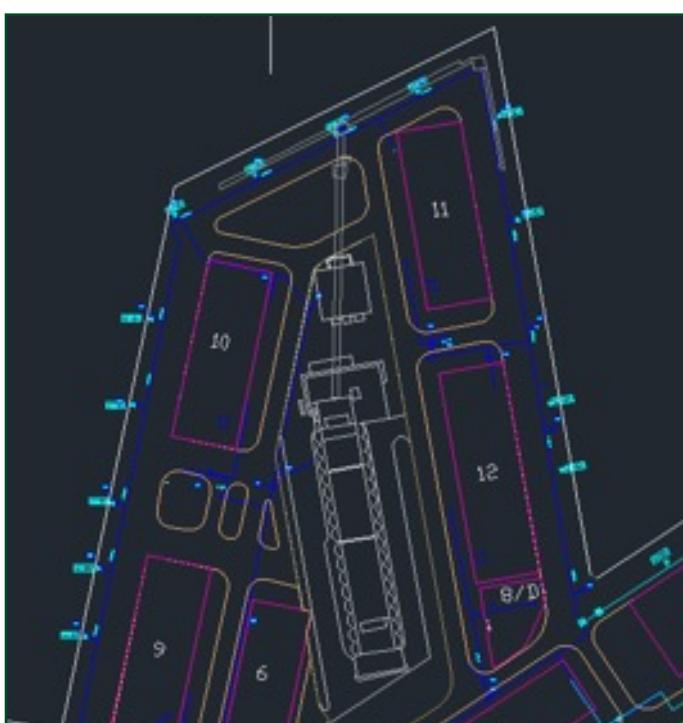
Figure 5: Facilities condition

No information was provided on the status of the networks or their observed conditions. However, as an example as seen in the figure adjacent (potable water network, blue lines), a section of the potable water network ran directly through the location of the explosion, thereby rendering through least this section of the network unusable.

Facilities such as sewage treatment/pumping stations and electrical sub stations shall also be inspected as part of the utility systems. The following electrical and water facilities were recorded in the report prepared by the Management and Investment of the Port of Beirut (24th August 2020), with their associated damages:

Following the explosion and subsequent shock wave, such services may have been damaged due to excessive vibrations and/or shifting of foundations, which in turn may have damaged the concrete channels, pipes or ducts.

Due to the importance of such services, it is highly recommended that the full extent of utility networks surrounding the explosion are surveyed for damage. It also needs to be determined that their capacities are in line with their designs.

Utility network functionality testing can be initially completed with a simple capacity check ensuring outputs align with their original designs (e.g. adequate water pressure for water network at taps/buildings). In the case of obvious discrepancies, or when a complete lack of delivery of a utility is observed, further detailed investigation will need to be undertaken which may involve excavation of sections to visually and physically test for leaks or disruptions in electrical or IT cabling.
